# Operating experiences with the TFTR escaping alpha detectors

S. J. Zweben, R. Boivin, D. Darrow, D. Loesser, S. S. Medley, M. McSmith, D. K. Owens, and M. Ulrickson

*Princeton Plasma Physics Laboratory, Princeton University, Princeton, New Jersey 08543*

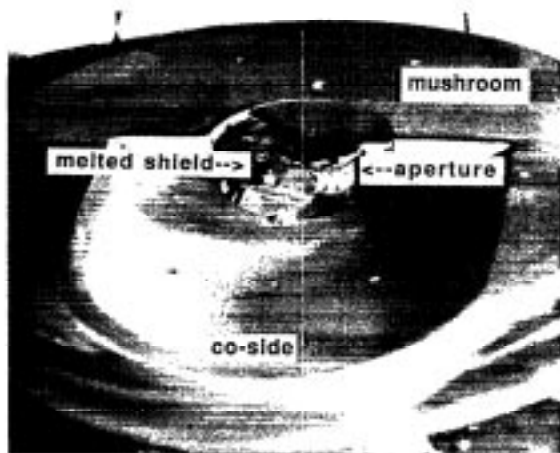
The worst overheating damage can be seen in the photograph of the 60° detector shown in Fig. 2, which represents the integrated effect of 10 000 shots in the 1991 run.

A significant part of the graphite and tantalum cap has been melted on the co-side edge. About 0.5 cm<sup>3</sup> of graphite was also eroded from the edge of the graphite cap of the 45° detector, and there is evidence that the braze to the tantalum melted. The stainless steel detector boxes of the 60° and the 45° detectors were also slightly melted by the co-side plasma heat flux. A small hole was melted through the top of the co-side of the 45° detector box, and the quartz scintillator just inside this spot was cracked (as was the 60° scintillator).

Analysis of the pattern of the damage shown in Fig. 2 implies that the average heat flux on the edge of the graphite cap heat flux was 2 kW/cm<sup>2</sup>, with a radial scrape-off layer distance for power of about 1 cm. Note that the 90°

FIG. 2. Damage to the 60° detector during the 1991 run, during which the mushroom top was 0.1 cm behind the rf limiter radius. There was significant melting of the soft x-ray shield and graphite cap, and slight melting of the stainless steel detector box due to plasma heat flux from the co-side.

The damage to the 45° and 60° detectors such as shown in Fig. 2 was caused by plasma heat flux in the scrape-off layer coming from the co-direction with respect to the plasma current (the same direction as the escaping fast ion orbits). No attempt had been made to shield heat from this direction, since it was thought that the magnetic field lines from this direction were always originating from the wall and not from the plasma edge.

Another factor contributing to the damage of the 45° and 60° detectors was the neglect (in the original design) of the effect of toroidal field ripple on the detector positioning. Since the detector tops were in the low- $B$  field (between coils), whereas the co-side rf limiter was in the high- $B$  field region, the magnetic field lines extended outward in minor radius by about 0.5 cm between the co-side rf limiter and the detectors. Thus the tops of the 45° and 60° detectors were magnetically a few mm farther inside the rf limiter than assumed, adding to the damage at the tips of the detector boxes.

The three fixed position detectors were changed for the 1992 run as illustrated in Fig. 4. The main improvement is a carbon composite heat shield protecting the detector boxes from the co-side, which should be able to withstand a heat flux of 1.5 kW/cm<sup>2</sup> for up to 2 s. This shield has a cutout which is carefully designed to let ions into the aperture with  $\chi \approx 45^\circ\text{--}90^\circ$  and  $\rho > 2$  cm.

The other major change is active cooling of the graphite mushroom by water lines through a metal plate attached to its bottom. This is to insure that residual heat flow (from either side) does not cause the detector temperature to exceed  $\approx 100^\circ\text{C}$ . The heat-damaged 45° and 90° detectors will also be moved radially outward by about 0.5 cm to compensate for the toroidal field ripple. This should still allow all relevant ions to enter the aperture unblocked by the rf limiter.

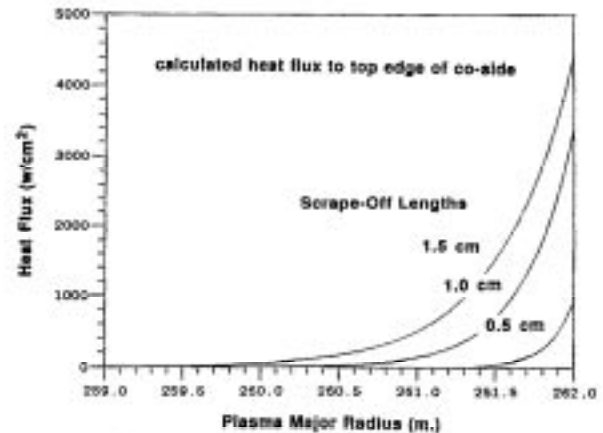
FIG. 3. Model of co-side heat flux vs plasma major radius position for the 45° detector for various scrape-off layer thicknesses. The relative heat flux increases dramatically for  $R > 2.59$  m because the field lines connected to the detector move inward radially past the co-side rf limiter. The absolute value in W/cm<sup>2</sup> is an estimate for a high power beam discharge.

However, this was evidently not the case for the large major radius plasmas, as described above. These observations motivated a recent reanalysis of the heat flux expected from the co-side to an object in the scrape-off region, with results for the 45° detector shown in Fig. 3 (the other detectors had similar results).

The model of Fig. 3 shows that the heat flux to the co-side of an object at the toroidal location of the detectors varies dramatically with the plasma major radius. When the plasma position is  $R < 2.59$  m, the field lines from the co-side of the detector tilt radially outward by up to 10° when moving toward the co-side limiter, so plasma flow from that direction is blocked (as assumed previously). However, when  $R \approx 2.6$  m, the outer magnetic flux surfaces are nearly concentric with the nearest co-side rf limiter (centered at  $R = 2.61$  m and about 2 m away toroidally), so that the detector tops are within the power radial scrape-off width of this limiter. Further, when  $R > 2.6$  m the field lines can entirely miss the nearest co-side limiter, and so accumulate heat flux over a very long connection length, resulting in a larger heat flux and scrape-off layer thickness. The results of this model agree at least qualitatively with the observed thermocouple readings versus  $R$  and damage patterns.

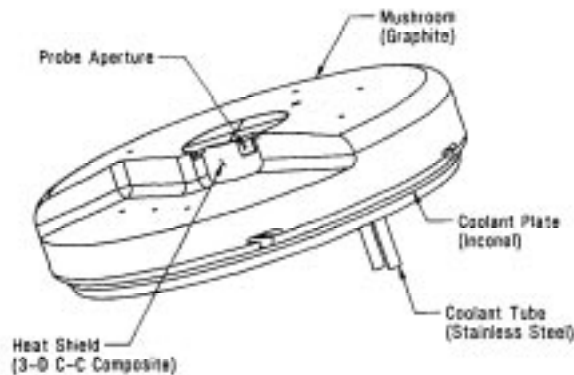
FIG. 4. New design of the escaping alpha detectors. There is now a cylindrical heat shield protecting the detector from the co-side, and the bottom of the graphite mushroom is actively cooled with water lines. The damaged detectors at 45° and 60° were also replaced and retracted about 0.5 cm for the 1992 run.
