# Operating experiences with the TFTR escaping alpha detectors

S. J. Zweben, R. Boivin, D. Darrow, D. Loesser, S. S. Medley, M. McSmith, D. K. Owens, and M. Ulrickson

*Princeton Plasma Physics Laboratory, Princeton University, Princeton, New Jersey 08543*

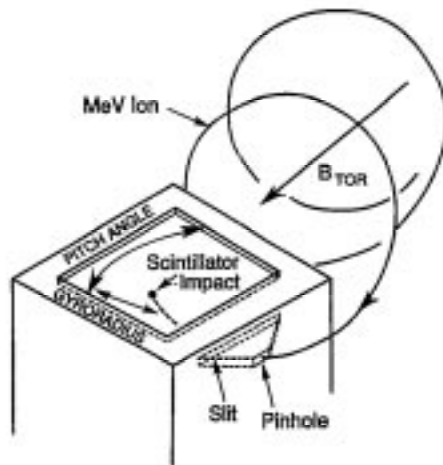
FIG. 1. Schematic drawing of the escaping alpha scintillator detector. This detector box was enclosed in a heat shield for the 1991 run, but was unprotected from the co-side (from which the escaping ions come).
